SAMPLE REPORT No. 3

CAMSHAFT FROM THE ENGINE OF A FAMILY MPV CAR

FAILURE ANALYSIS

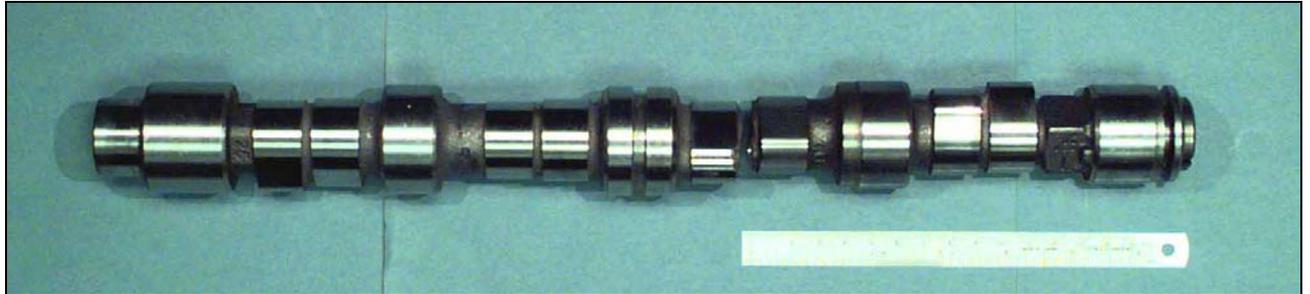
- (1) The fracture had occurred approximately 1/3 of the length of the shaft from one end (figure 1). It had initiated on the ground surface of one of the cam lobes but progressed into the radius between two adjacent cams after a short distance.
- (2) The initial period of crack growth had produced a shallow trough in the fracture surface (figure 2). Within the trough, the surface was relatively smooth in texture and was considered to be typical of fatigue crack growth. The remainder of the fracture surface was relatively coarse in texture, showing evidence of the as cast microstructure of the shaft. This was considered to be typical of fracture due to static overloading.

Figure 1 - General view of the fractured camshaft.

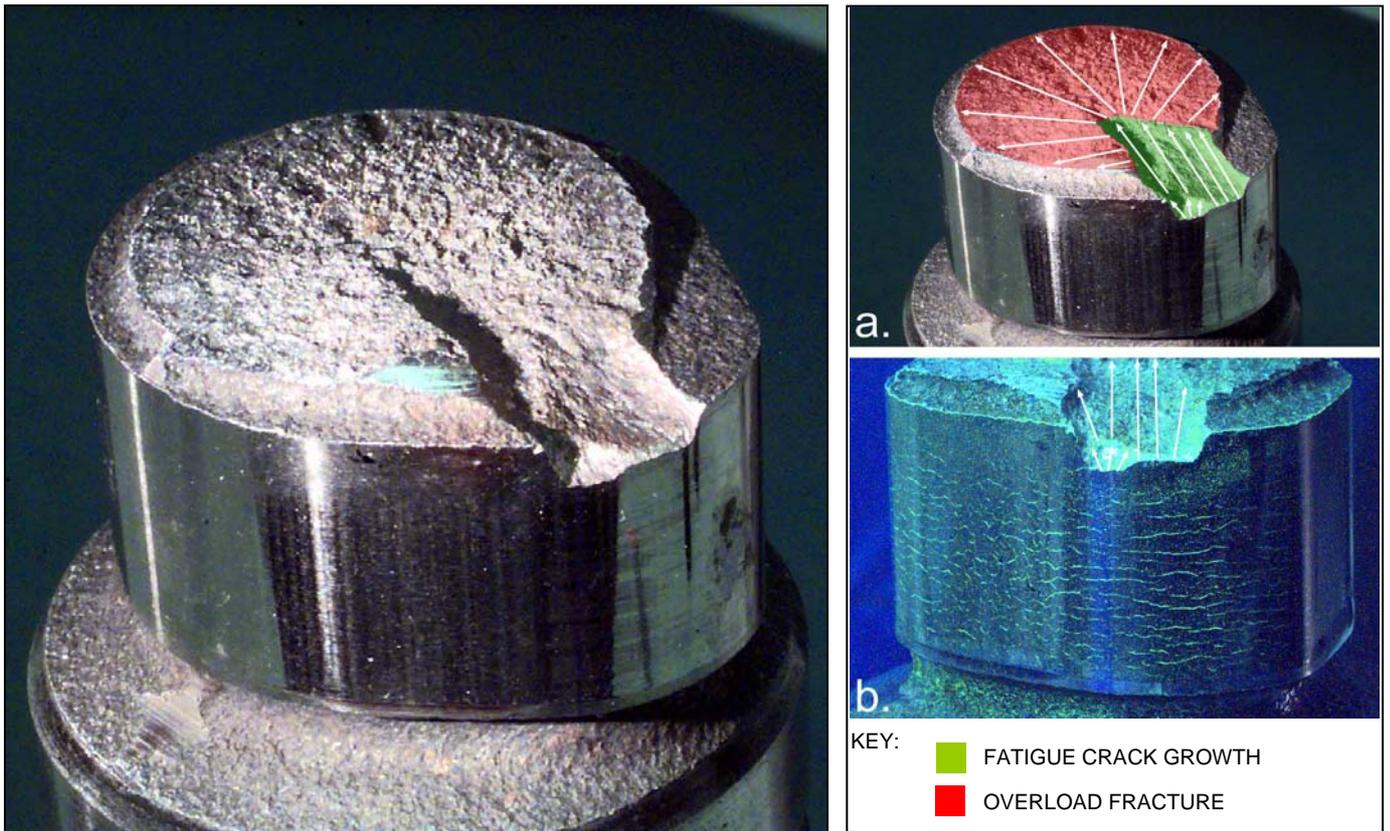
- (1) The magnetic particle inspection revealed numerous microcracks on all of the cam surfaces (figures 3 and 4). The severity of cracking was largely consistent around the circumference of each of the cams. It was apparent that the fatigue crack detailed above had originated from two of these micro-cracks (figures 2 and 4).

Figure 2 - Close view of the fracture surface.

- a. Schematic of the fracture mechanism.
- b. Fatigue crack initiation from surface cracking, viewed under ultra-violet light, during magnetic particle inspection.

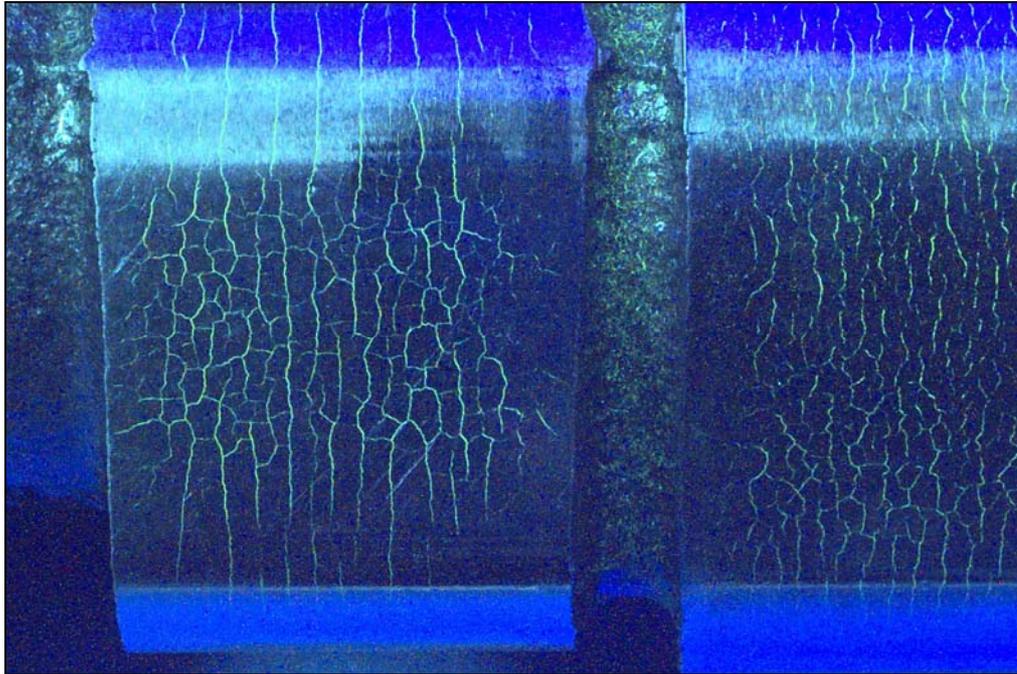
- B. The appearance of the micro-cracks on the cam surfaces was typical of abusive grinding, performed during manufacturing of the shaft. Grinding operations performed either off-centre, with insufficient lubrication, or using excessive feeds and speeds cause frictional heating, which may result in very high surface temperatures. In severe cases, the maximum temperature attained may be sufficient to alter the crystal structure

of the alloy surface. This produces significant residual stress in the surface, which may result in cracking of the type shown in figures 3 and 4.

Figure 3 - Close view of surface micro-cracking on two of the cam surfaces, highlighted by magnetic particle inspection.

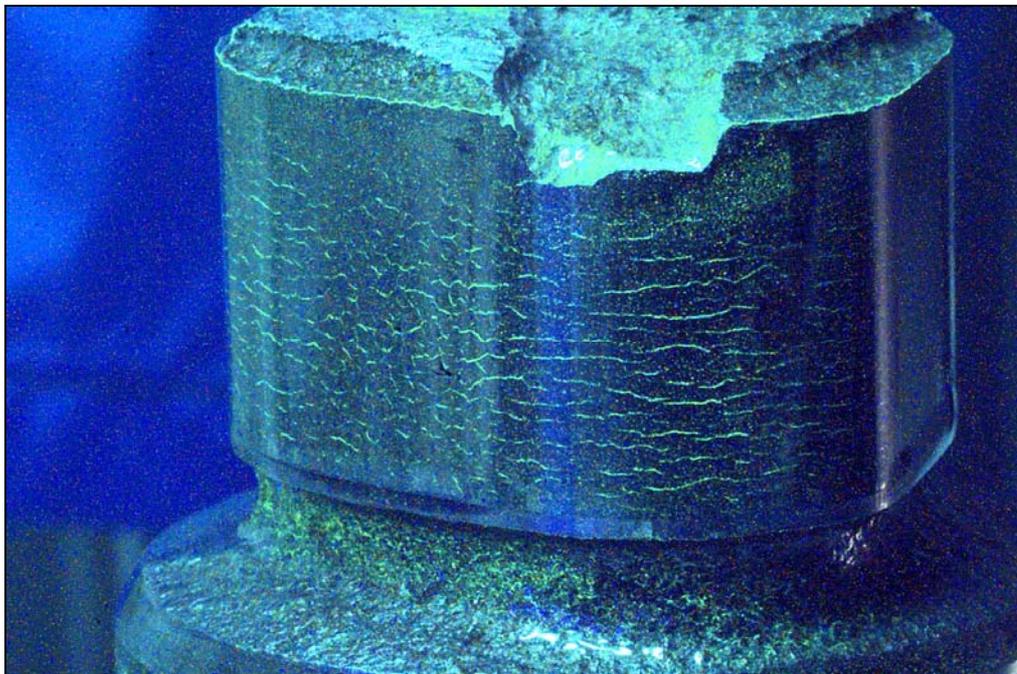
- A. The subject camshaft failed as a result of fatigue fracture under apparently normal operating conditions. The fatigue fracture had initiated from micro-cracking in the ground surface of one of the cams.
- B. The micro-cracking present on the cam surfaces had been caused during manufacture of the camshaft, as a result of abusive grinding.

Figure 4 - Close view of fatigue crack initiation from micro-cracks in the ground surface of one of the cams. Viewed under ultra-violet light, during magnetic particle inspection.
