SAMPLE REPORT No. 2

**LP TURBINE BLADES, FROM A TURBOFAN ENGINE, FITTED TO A
LARGE PASSENGER AIRCRAFT**

FAILURE ANALYSIS

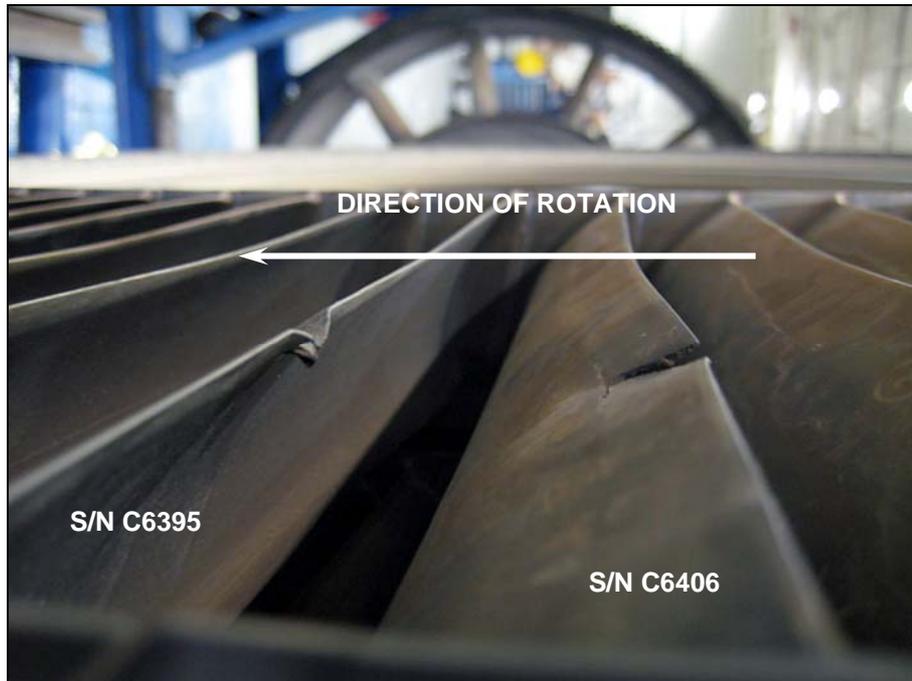
- A. On 25 May 2007, the captain of the subject aircraft reported vibration from the no.1 engine, during climb. Subsequent examination of the engine revealed damage to the trailing edges of two low pressure (LP) turbine blades (figure 1). No evidence of damage elsewhere in the engine was reported.

Figure 1 - The two damaged blades, in situ on the LP turbine disc (photograph supplied by customer).

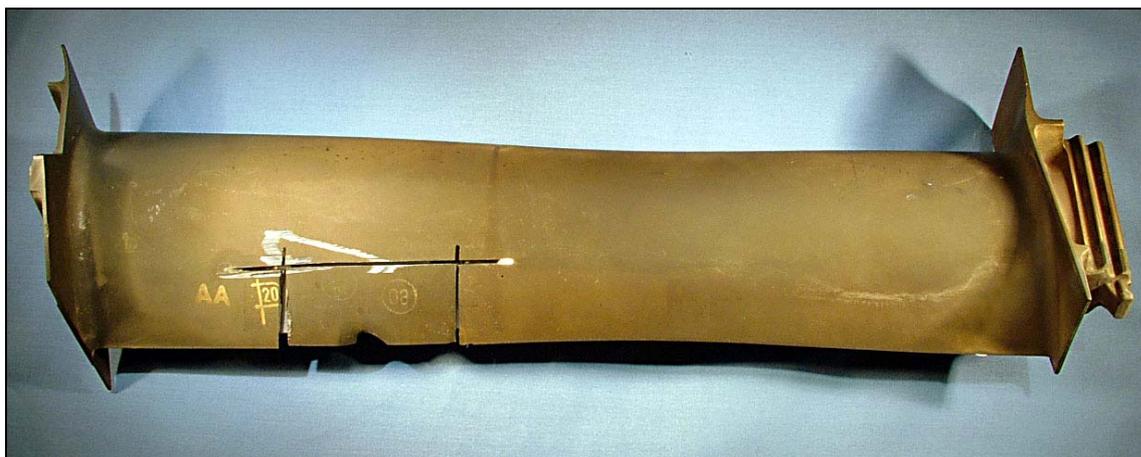
- (1) On both blades, the damage had occurred at approximately the $\frac{3}{4}$ span position, at the trailing edge (figures 2 to 5).
- (2) **Blade C6395**
 - (a) This blade had suffered impact, directly on the trailing edge itself (figures 6 and 7), resulting in a roughly semi-circular indentation. The blade alloy had been locally deformed from the convex, towards the concave face. This was consistent with impact by a hard, solid object, during engine running.
 - (b) Traces of solid, foreign material were present at the impact site (figure 6). These were most likely associated with the foreign object, which had caused the damage.
- (3) **Blade C6406**
 - (a) This blade had also suffered impact by a hard foreign object. A rectangular imprint indicated that the impact site was located on the convex surface,

Figure 2- Blade C6395, convex side. The sectioning had been performed during an earlier investigation, at another laboratory.

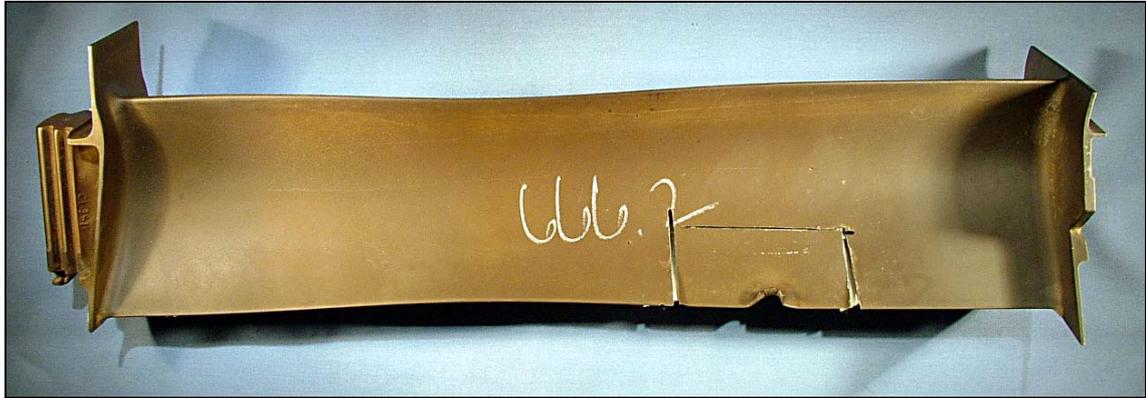
Figure 3 - Blade C6395, concave side. The sectioning had been performed during an earlier investigation, at another laboratory.

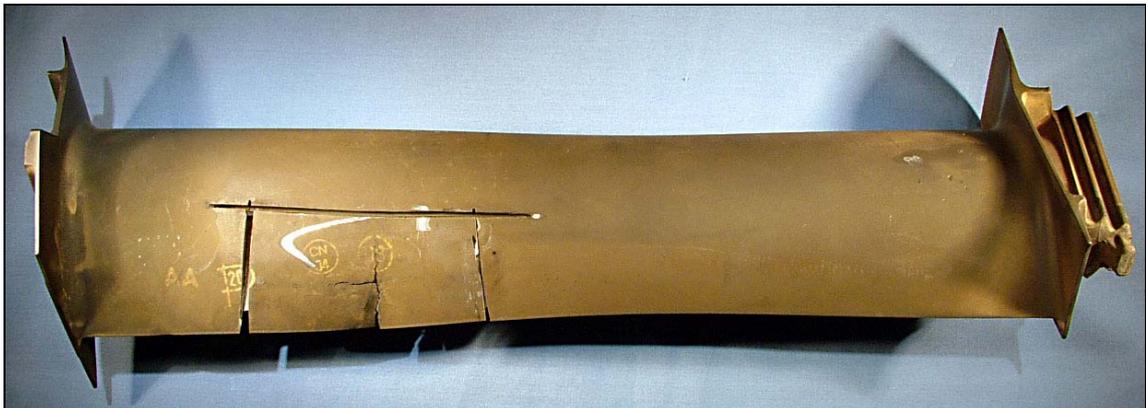
Figure 4 - Blade C6406, convex side. The sectioning had been performed during an earlier investigation, at another laboratory.

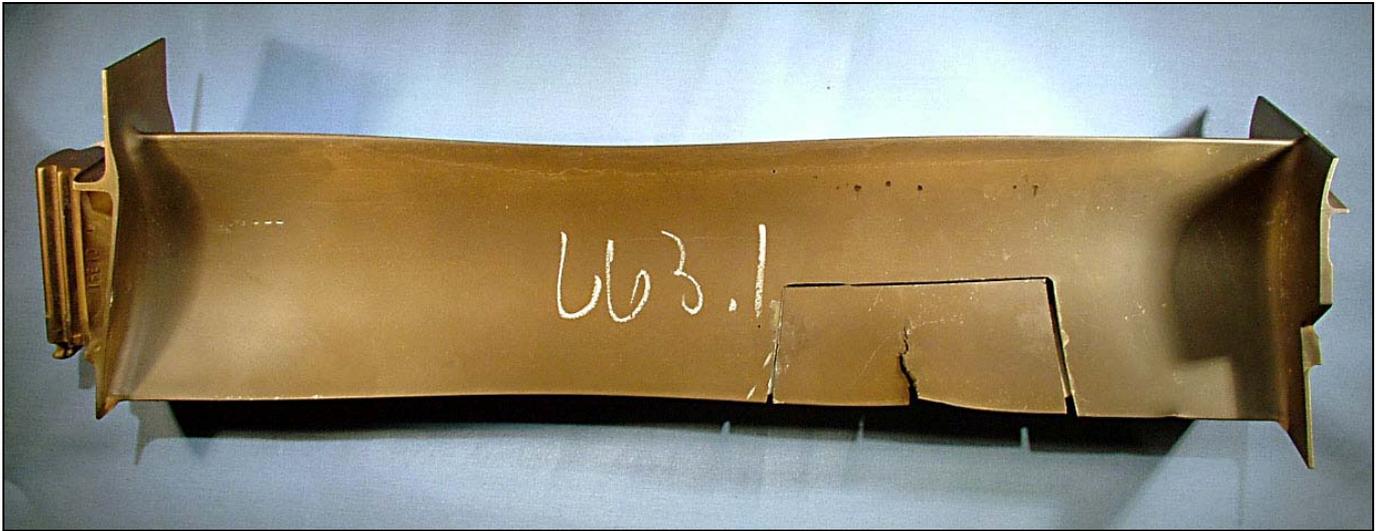
Figure 5 - Blade C6406, concave side. The sectioning had been performed during an earlier investigation, at another laboratory.

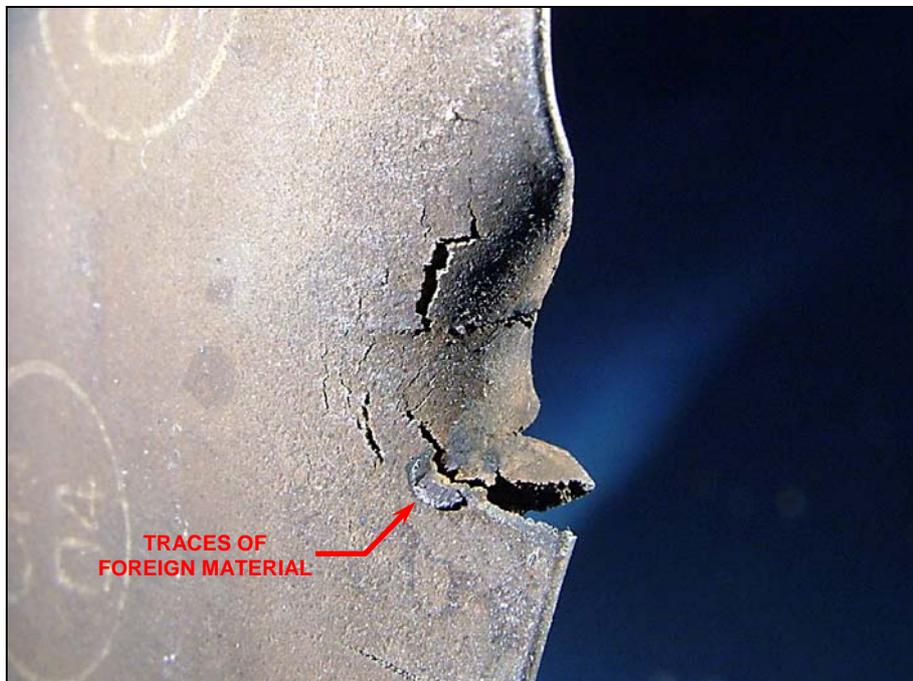
Figure 6 - Blade C6395, convex side, trailing edge. Impact damage directly on the trailing edge has resulted in a roughly semi-circular indentation. Traces of foreign material, most likely associated with the impacting object, is present on the surface of the blade.

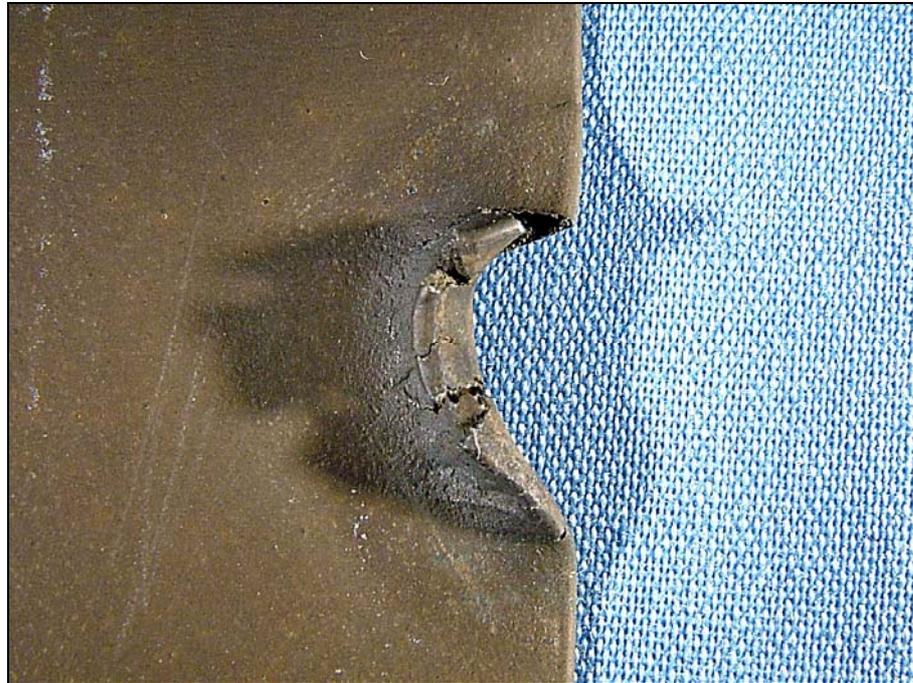
Figure 7 - Blade C6395, concave side, trailing edge. Deformation of blade material, caused by impact with a foreign object.

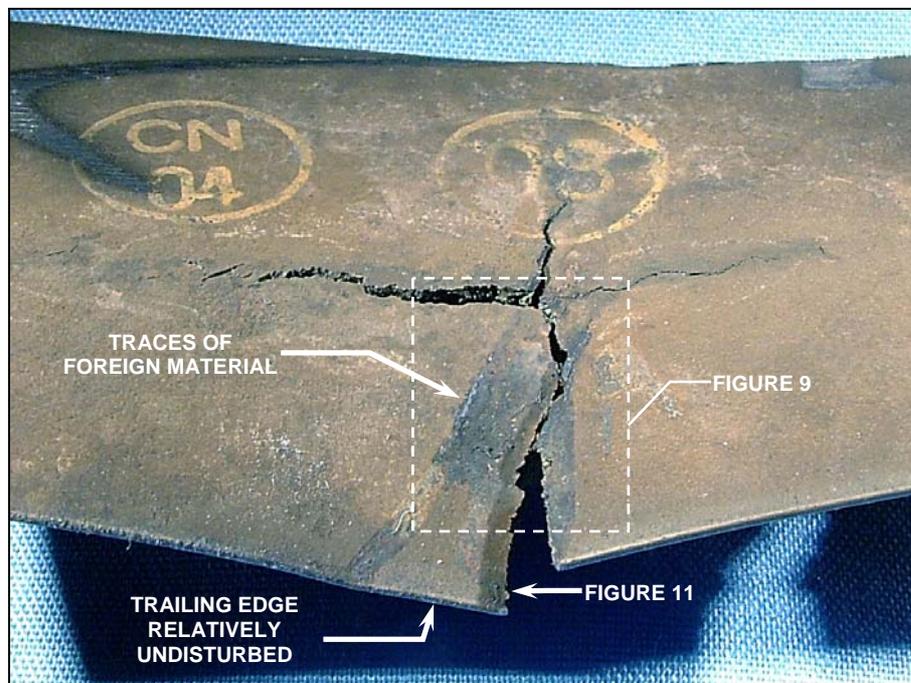
approximately 5-15mm inwards from the trailing edge (figure 8). The trailing edge, itself was comparatively undisturbed.

Figure 8 - Blade C6406, convex side, trailing edge. Imprint and traces of foreign material indicate impact by an elongated foreign object a short distance from the trailing edge. Note that the trailing edge itself is comparatively undisturbed.

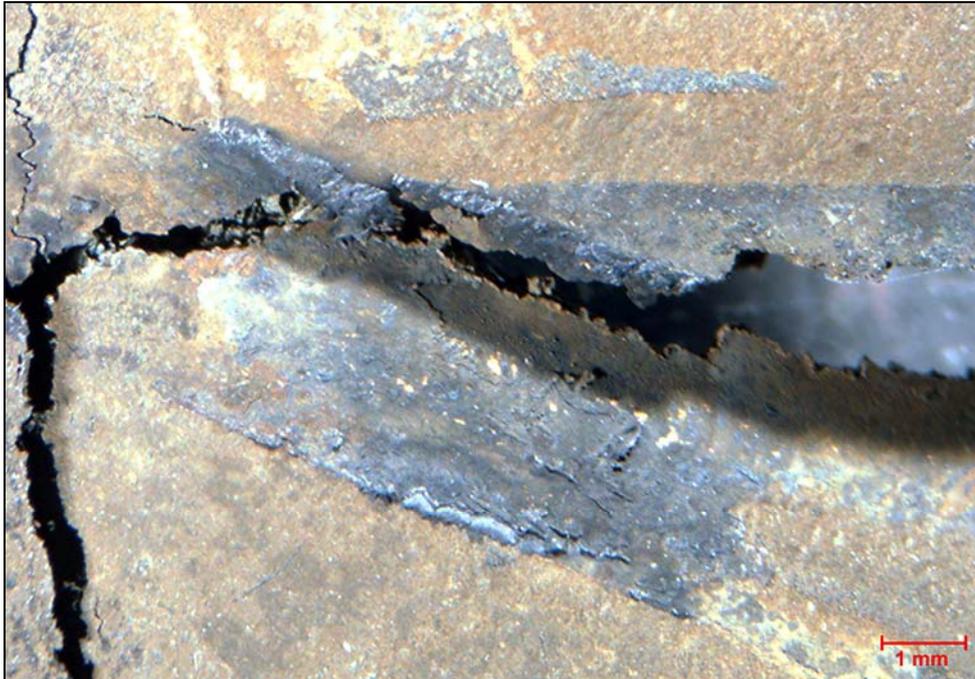
- (b) The imprint detailed at 3.A.(3)(a) above, was delineated by traces of foreign material, associated with the object which had caused the damage (figure 9). The dimensions of this imprint, coupled with those of the damage found on blade C6395, suggested that the damage may have been caused by a cylindrical object, approximately 10mm long by 5mm diameter.
- (c) The impact had resulted in cracking of a cruciform nature on the convex surface (figure 8). The spanwise branches of the cracking coincided with the boundaries of the solid trailing edge and the hollow core regions of the aerofoil. The transverse branches of the cracking extended for approximately 25mm, normal to the major axis of the aerofoil. Deformation of the blade alloy was again consistent with the impact having occurred during engine running.

Figure 9 - Blade C6406, convex side, trailing edge. Close view of the region indicated in figure 8. Traces of foreign material left by the impacting object.

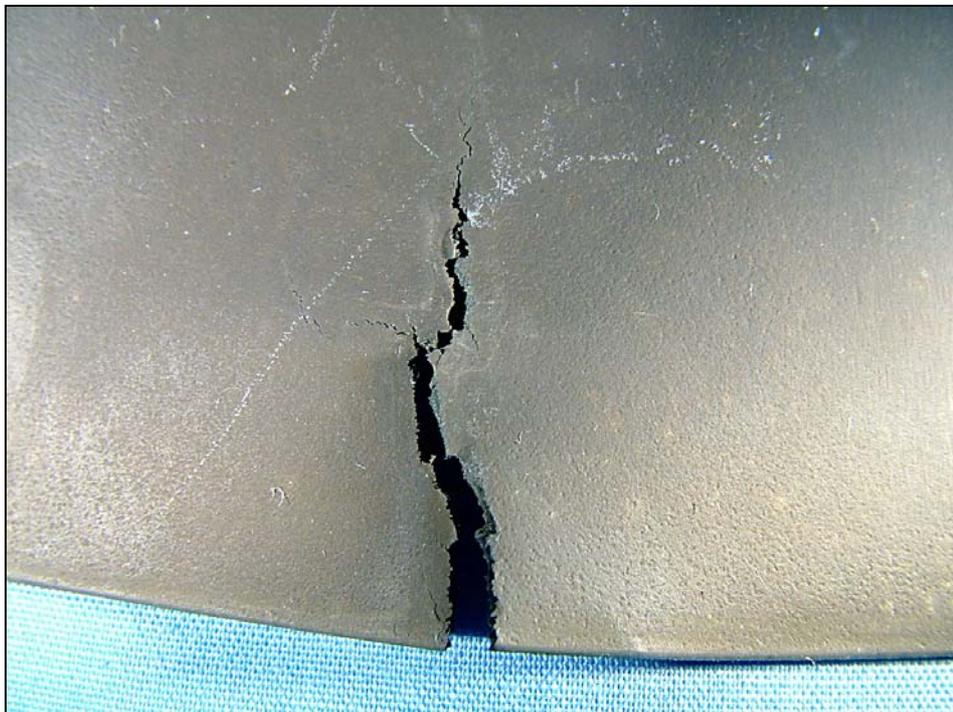
Figure 10 - Blade C6406, concave side, trailing edge. Note the jagged, intergranular nature of the cracking.

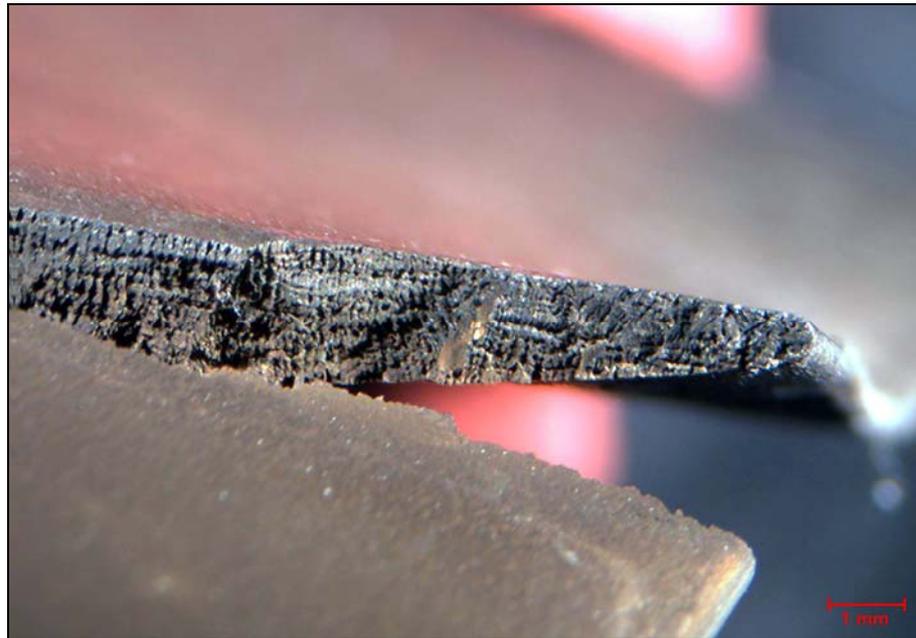
- (1) On blade C6406, the majority of the transverse crack surface area was composed of intergranular fracture, with clearly visible dendritic outlines (figures 11 and 12). This was consistent with high energy, overload fracture, occurring at elevated temperature. A very light covering of oxidation and combustion products was present on the crack surfaces. This indicated that a short period of engine running had ensued, after the occurrence of the impact damage.
- (2) A small, thumbnail shaped region of fatigue crack growth was present, located at the tip of the overload crack detailed at 3.B.(1) above (figures 12 to 14). The curvature of arrest markings indicated that the fatigue crack had originated from the overload crack. Stable fatigue crack growth had progressed only for a distance of approximately 1mm.

Figure 11 - Blade C6406, trailing edge, close view on the fracture surface indicated in figure 8. Dendritic outlines clearly visible on the fracture surface indicate intergranular fracture. Combustion products and only very light oxidation are also evident.

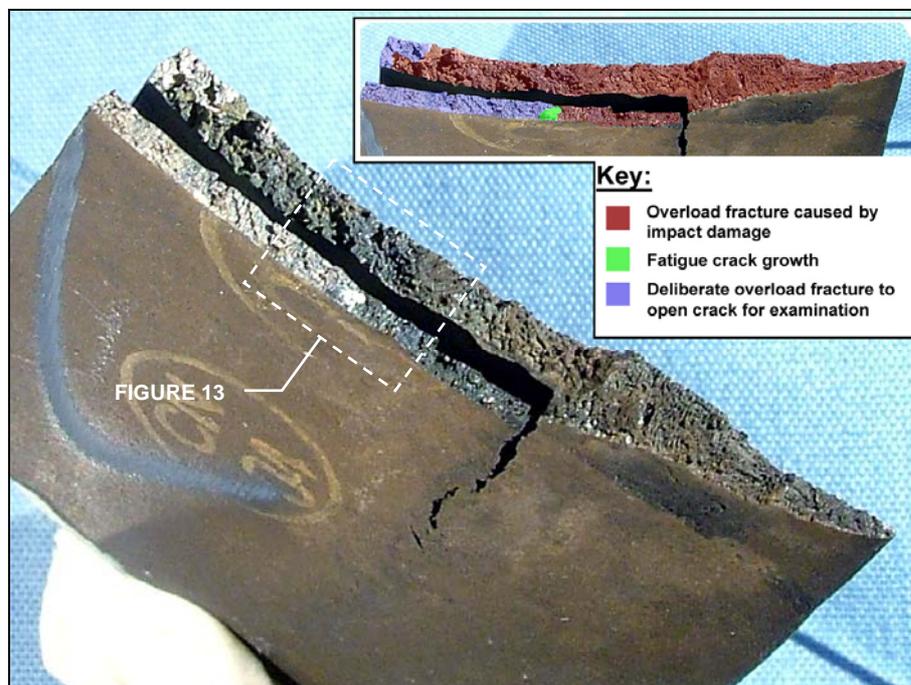
Figure 12 - Blade C6406. The transverse crack shown in figure 8 has been broken open, to allow examination of the crack surfaces. The inset shows the fracture mechanisms of the different regions of the crack surface.

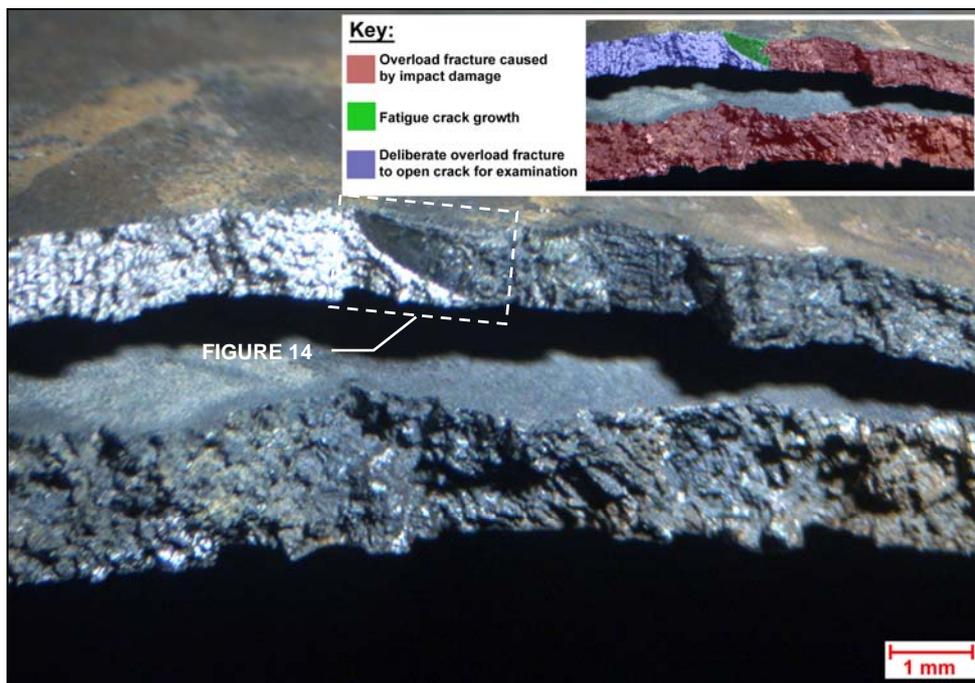
Figure 13 - Blade C6406, close view of the region indicated in figure 12 (note – this photograph shows the opposite crack surface to that shown in figure 12). The inset shows the fracture mechanisms of the different regions of the crack surface. Note the thumbnail shaped region of fatigue crack growth.

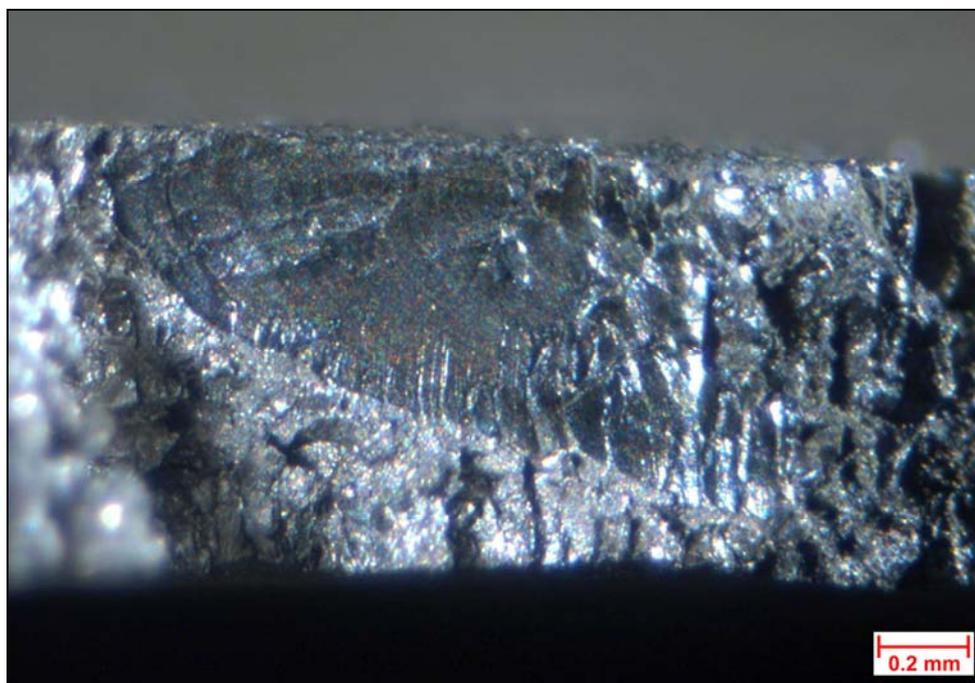
Figure 14 - Blade C6406, close view of the region indicated in figure 13. Shows the region of fatigue crack growth, originating from the overload crack which had been caused by impact damage.

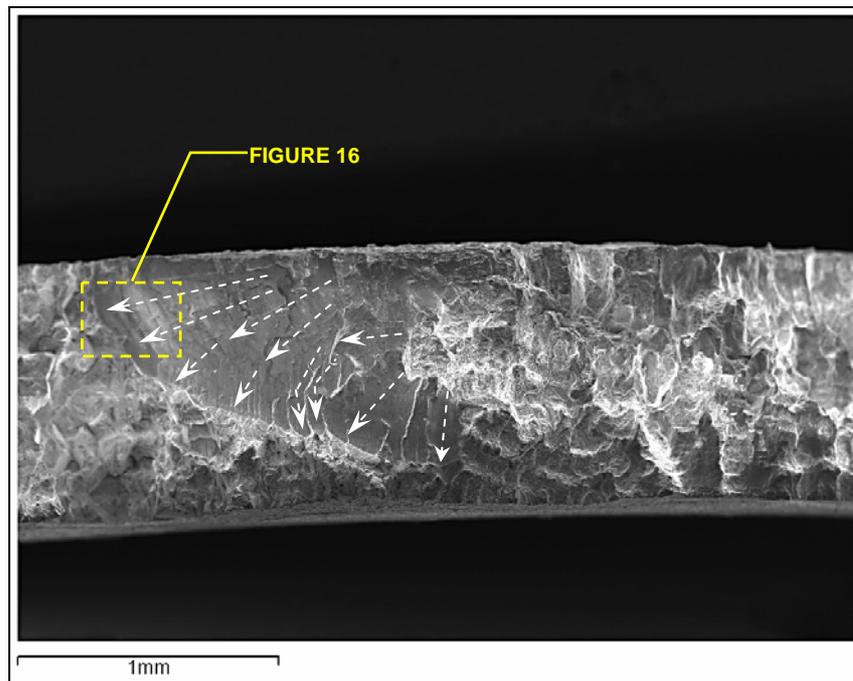
Figure 15 - Blade C6406, close view of the region of fatigue crack growth. Arrows indicate directions of crack growth, determined from the curvature of fatigue striations (secondary electron image).

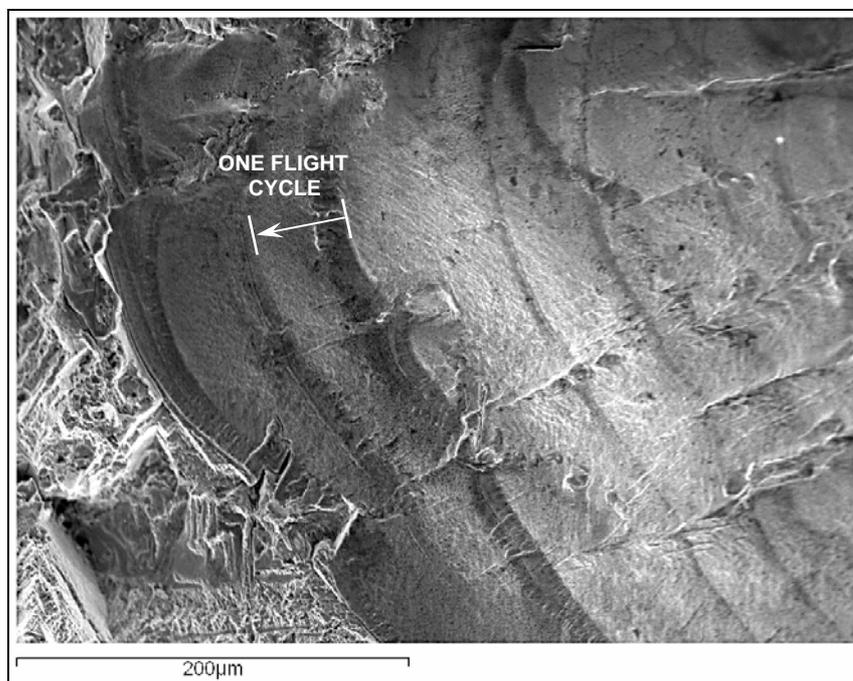
- (3) When examined in the SEM, fatigue striations were evident on the fatigue crack surface (figure 16). The striation spacing showed a distinct periodicity, with groups of widely spaced striations interposed by groups of more narrow spacing. It was considered that this periodicity could be correlated to flight cycles in the following manner:-

- (c) It follows from (a) and (b) above that the distance from the beginning of one group of wide striations to the beginning of the next would correspond to a single flight cycle (figure 16).

- (4) By counting groups of fatigue striations, it was estimated that the period of stable crack growth lasted for between 15 to 30 flight cycles. It was not possible to be more precise in this determination, since periodicity in striation spacing could not be resolved for the first 0.5mm of crack growth. Data for this region had to be extrapolated from measurements taken from the second 0.5mm of crack growth.

Figure 16 - Blade C6406, close view of the region indicated in figure 15. Shows groups of widely spaced striations interposed by groups of more narrow spacing. This periodicity in striation spacing was considered to correlate with flight cycles (secondary electron image).

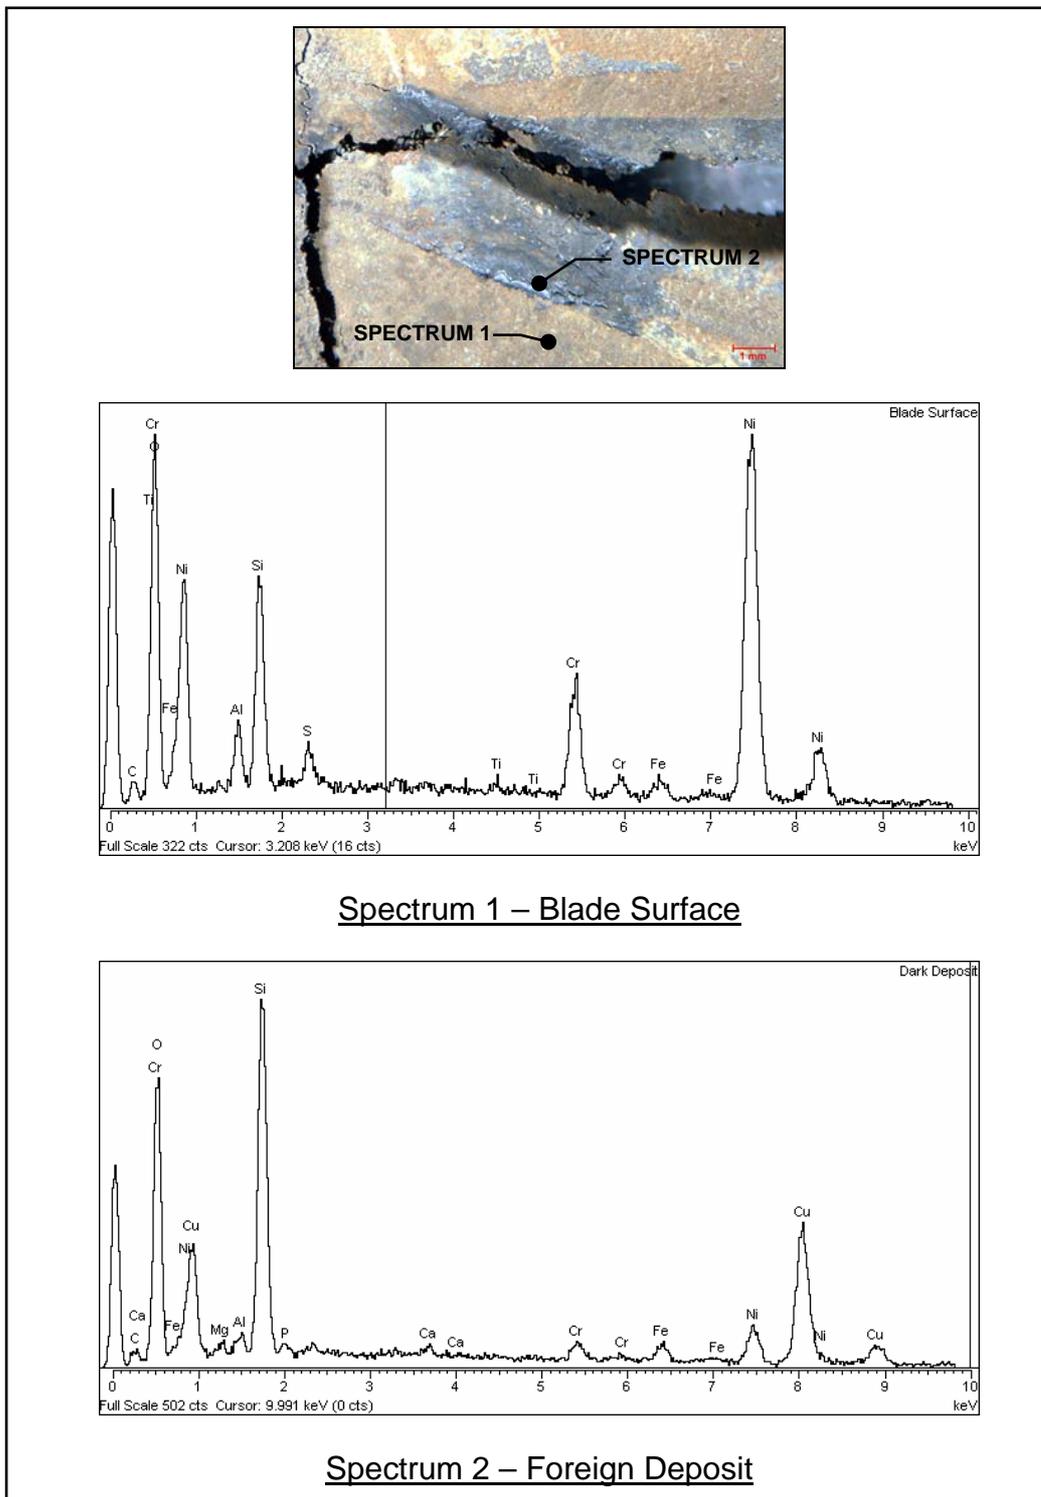
- (1) The EDX spectra obtained from the foreign deposits and the original blade surface are shown in figure 17. The deposits were found to be composed of a compound rich in copper.

- B. EDX analysis of foreign deposits found at the impact site showed that they were rich in copper. This indicated that the object which caused the damage was either rich in copper or was coated with a copper rich substance.

Figure 17 - Comparison of EDX spectra taken from the blade surface and foreign deposits, associated with the impact site on blade C6406. “Spectrum 1” is typical of the blade alloy, with surface contamination by silicon, most likely the result of combustion processes. “Spectrum 2” shows that the foreign deposit was composed of a substance rich in copper.
