SAMPLE REPORT No. 5

NOSE LANDING GEAR (NLG) SPIN BRAKE SPRING FROM A LARGE PASSENGER AIRCRAFT

FAILURE ANALYSIS

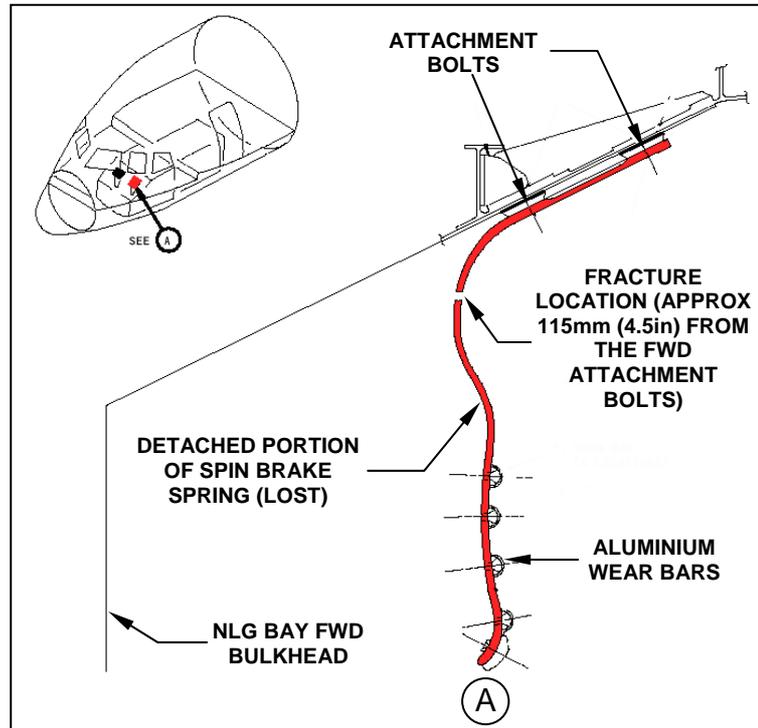
A. As the NLG was retracted, contact between the still spinning nosewheel and the wear bars of the spin brake assembly imposed cyclic bending stresses on the spin brake spring, in the forward direction (see figure 1). This, in turn, established cyclic tensile stresses on the concave face of the spring. Since no other failures of similar spin brake springs from the same aircraft type had been reported, it was reasonable to assume that under normal circumstances, the magnitude of these cyclic stresses would be below the threshold value required for fatigue crack initiation. On the subject spring however, the pitting present on the surface acted as sites of stress concentration, raising the magnitude of the cyclic stresses above this threshold. As a result, fatigue cracks initiated from the pits at numerous locations on the concave face of the spring. With continued cycling of the spring, the fatigue cracks grew and coalesced with each other until the remaining, uncracked ligament became unable to withstand the applied stress. At this point, final overload failure occurred.

Figure 1 - Schematic of the left hand, nose landing gear spin brake installation.

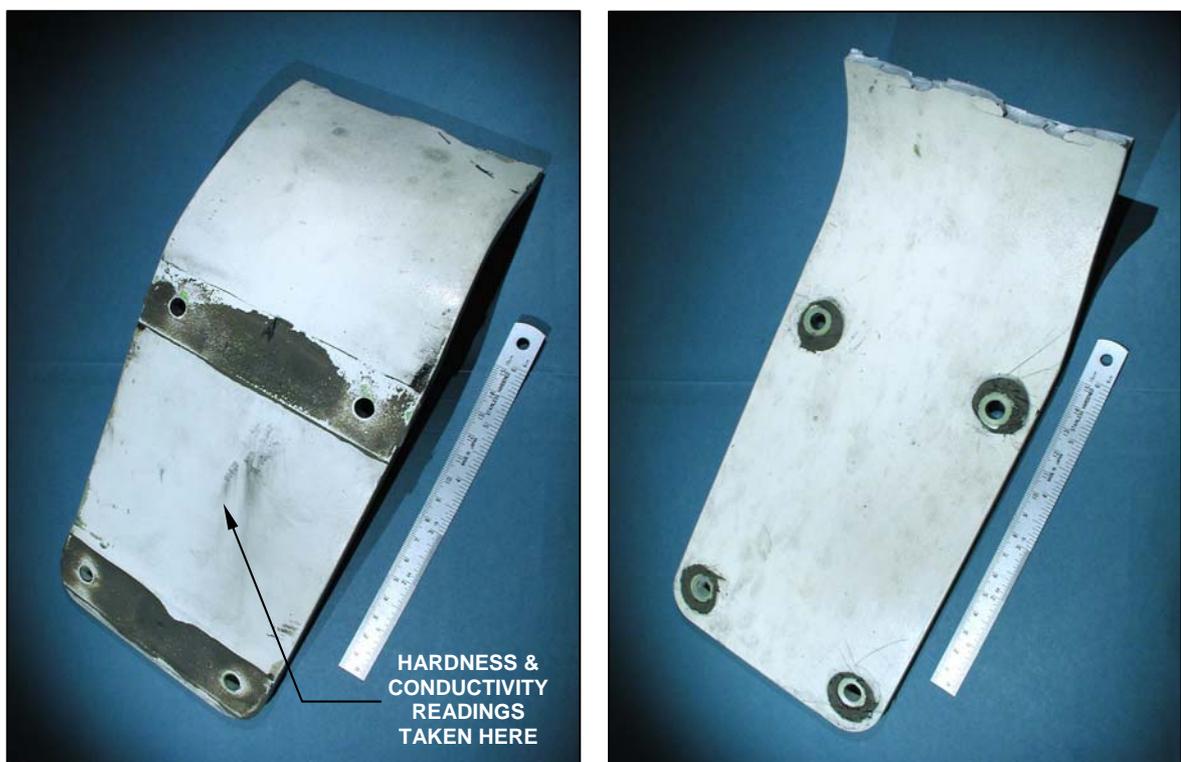
- B. The subject aircraft had suffered a history of noise on retraction of the NLG. In order to identify the source of the noise, the NLG bay was inspected. It was found that the LH spin brake spring had fractured approximately 115mm (4.5in) from the forward attachment bolts (see figures 1 and 2). The liberated portion had departed the aircraft and been lost.

Figure 2 - General views on both sides of the retained portion of the fractured spring.

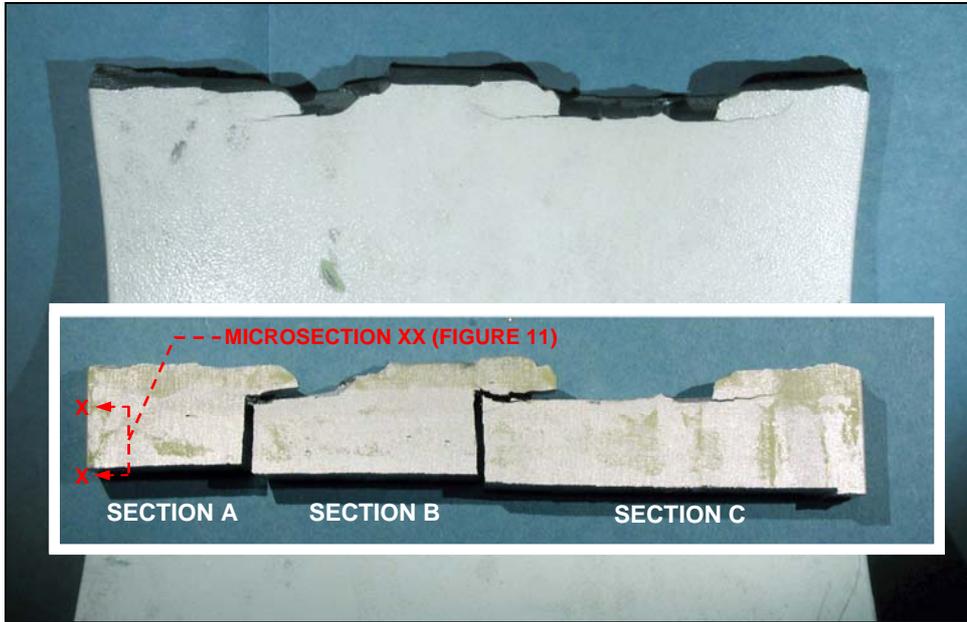
Figure 3 - Close view of the fracture location, from the concave face of the spring. The inset shows locations of sections made, to reveal previously obscured crack surfaces

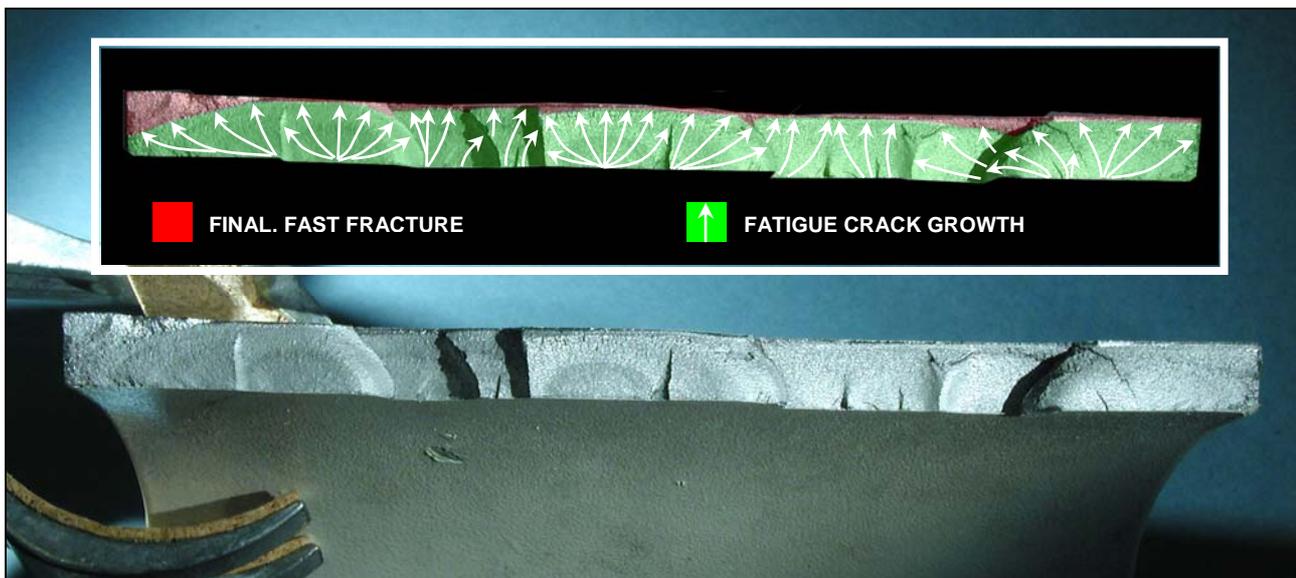
- (1) The fracture surface was composed of numerous, individual fatigue crack fronts (figures 2 to 7). The curvature of fatigue arrest markings on their surfaces indicated that each crack front had initiated at the concave surface of the spring. The major direction of crack growth was through the thickness of the spring, towards its convex surface. Ridges on the fracture surface indicated locations where the individual crack fronts had coalesced during propagation.
- (2) The fatigue crack fronts had penetrated almost the entire thickness of the spring. However, along the edge of the fracture surface, coincident with the convex face of the spring, there were very narrow “shear lips”, inclined at 45° to the major axis of the spring. This indicated the region of final, overload failure. The large surface

Figure 4 - Close view of the fracture surface, prior to sectioning. Numerous fatigue crack fronts were evident, each of which had initiated on the concave surface of the spring. The inset shows the directions and extent of fatigue crack growth.

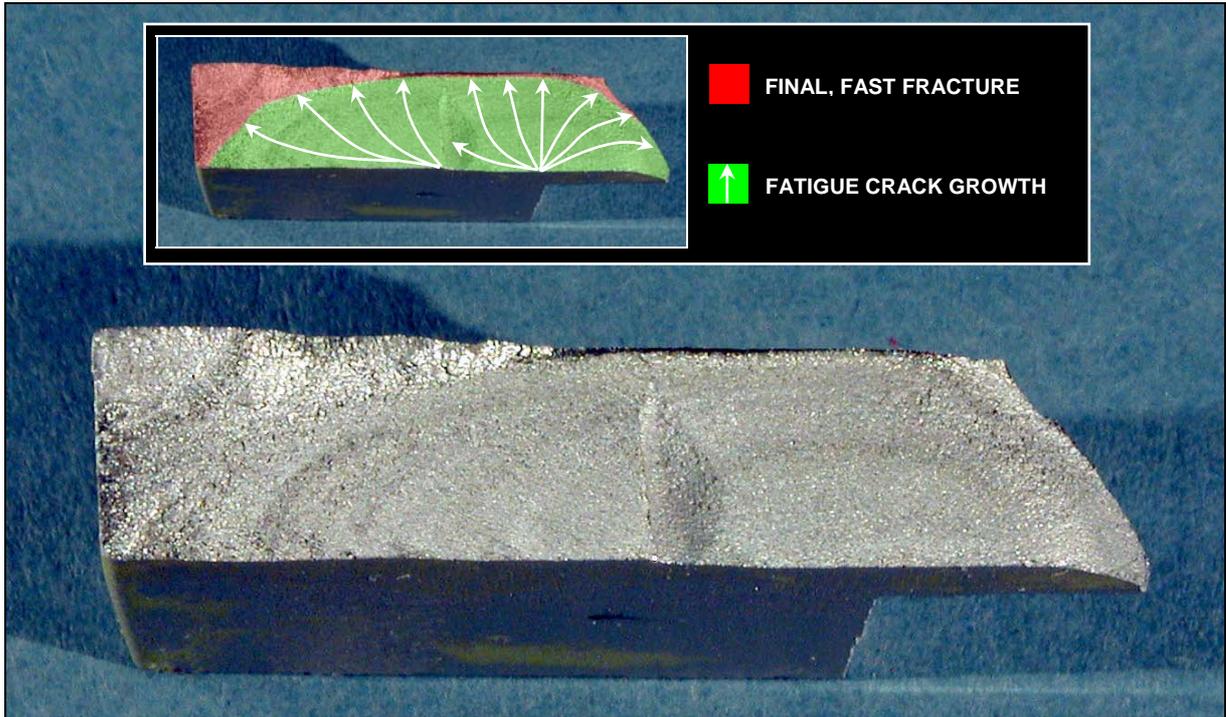
Figure 5 - Close view of the fracture surface of section A, as indicated in figure 3. Fatigue cracks had initiated at the concave surface of the spring and grew primarily in the direction of the convex surface.

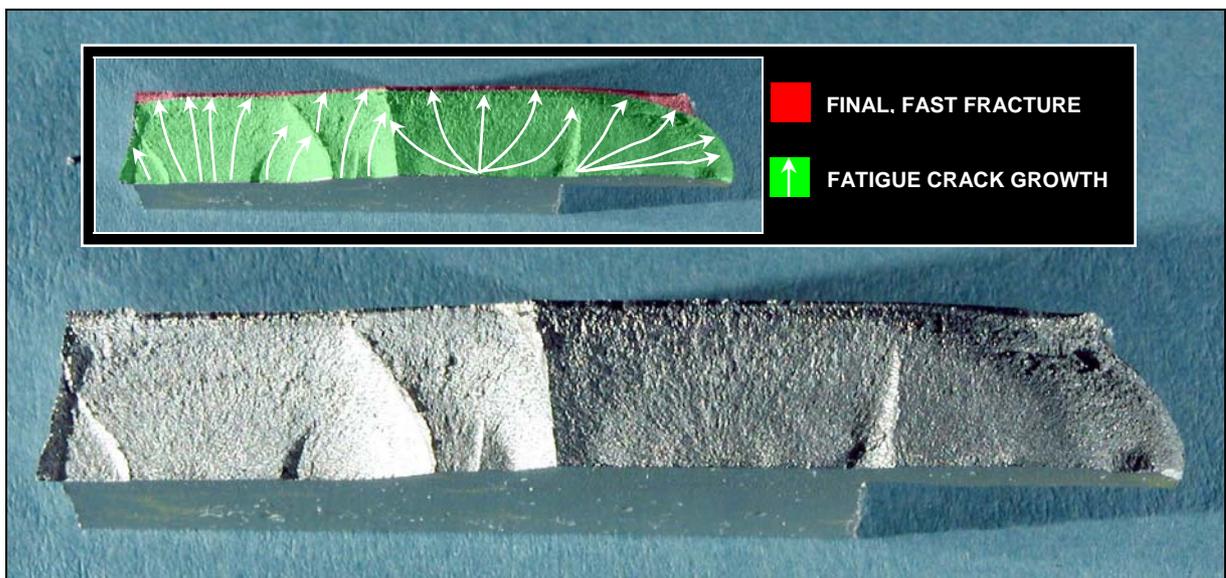
Figure 6 - Close view of the fracture surface of section B, as indicated in figure 3. Fatigue cracks had initiated at the concave surface of the spring and grew primarily in the direction of the convex surface.

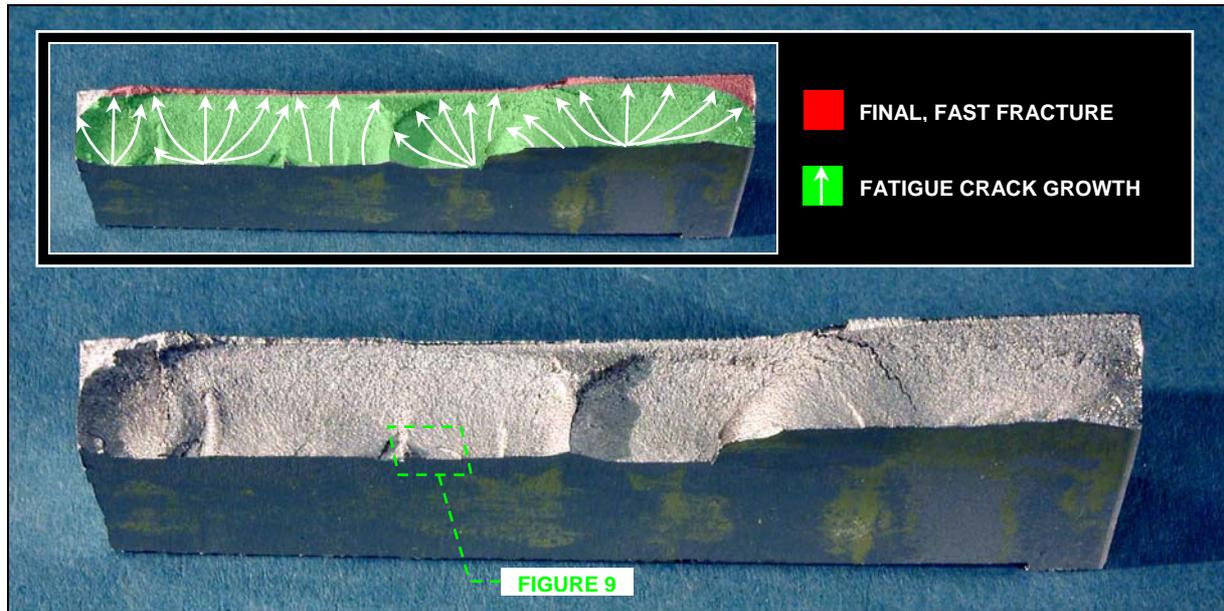
Figure 7 - Close view of the fracture surface of section C, as indicated in figure 3. Fatigue cracks had initiated at the concave surface of the spring and grew primarily in the direction of the convex surface.

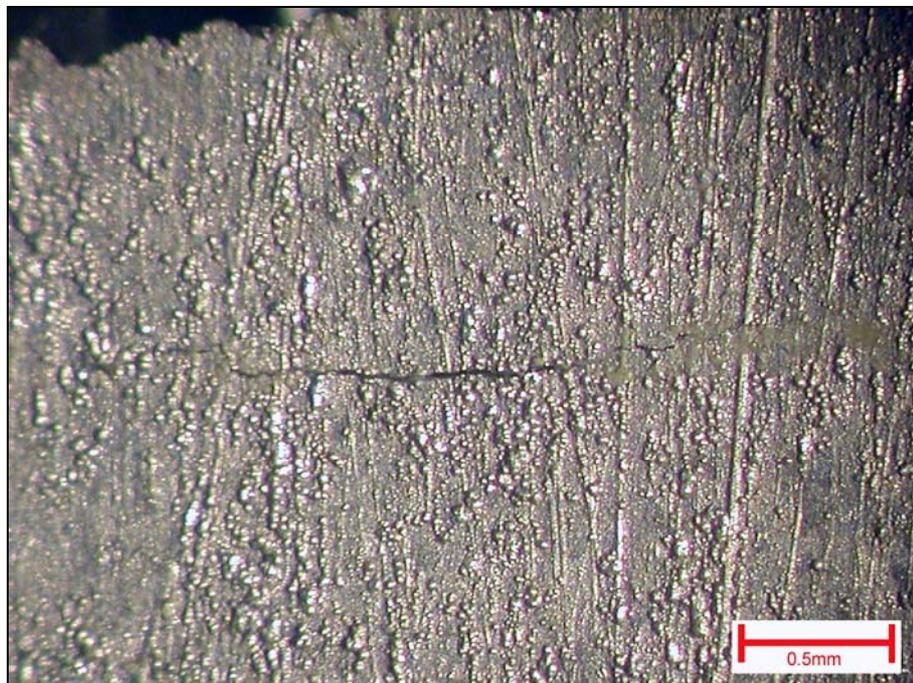
- (3) The organic coatings applied to the surfaces of the spring were fully adherent and in good condition. However, once these coatings were removed, severe pitting was evident in the alloy surface (figure 8). These pits were not considered to have been produced by in-service corrosion, due to their smooth and rounded morphology and the lack of any corrosion products. The density of the pitting was most severe at changes in section, such as the edges of the spring and along scratches in its surface
- (4) Several secondary cracks were evident, aligned parallel to the fracture surface. In each case, these appeared to have initiated from the pitting detailed above (figure 8).

B. The unbroken anodised coating with the surface pits indicated that they had been formed either before or during anodising. Their morphology was considered to be consistent with that produced by the application of excessive voltage during the anodising process. Under such conditions, the rate of dissolution is locally increased

in regions of point discharge, such as the edges of the component or scratches in its surface. This results in the formation of rounded pits of the type present on the subject spring.

Figure 8 - Close view of the concave face of the spring, adjacent to the fracture surface, after removal of the organic coatings. The surface was heavily pitted, consistent with the application of excessive voltage during anodising. Secondary cracks were present, which had initiated from the surface pitting.

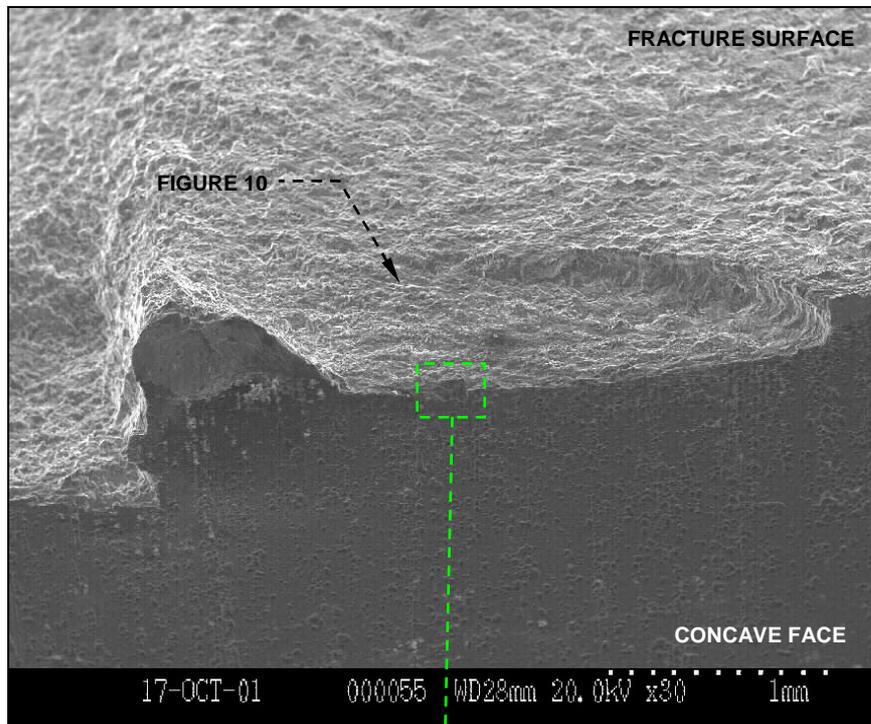
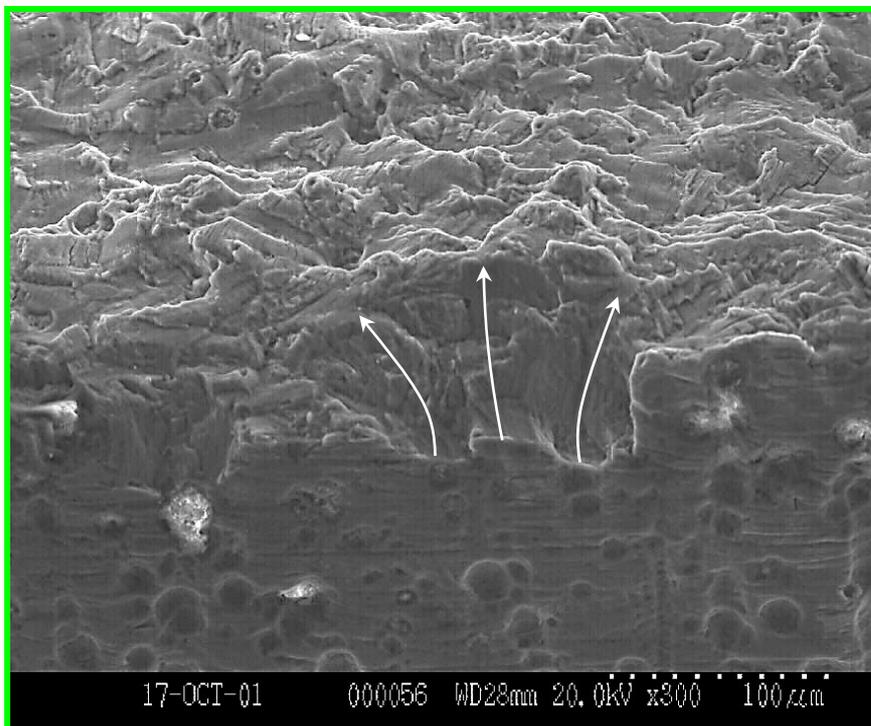
- (1) The curvature of fine fatigue striations on the fracture surface confirmed that the individual fatigue crack fronts had initiated from the surface pitting detailed at 3.A.(3) above (figures 9 and 10). The close spacing of the striations indicated that the crack growth mechanism was one of high cycle fatigue

Figure 9 - Close views of the one of the regions of fatigue crack initiation, as indicated in figure 7. Individual fatigue crack fronts had initiated from the pitting in the concave surface of the spring (secondary electron images).

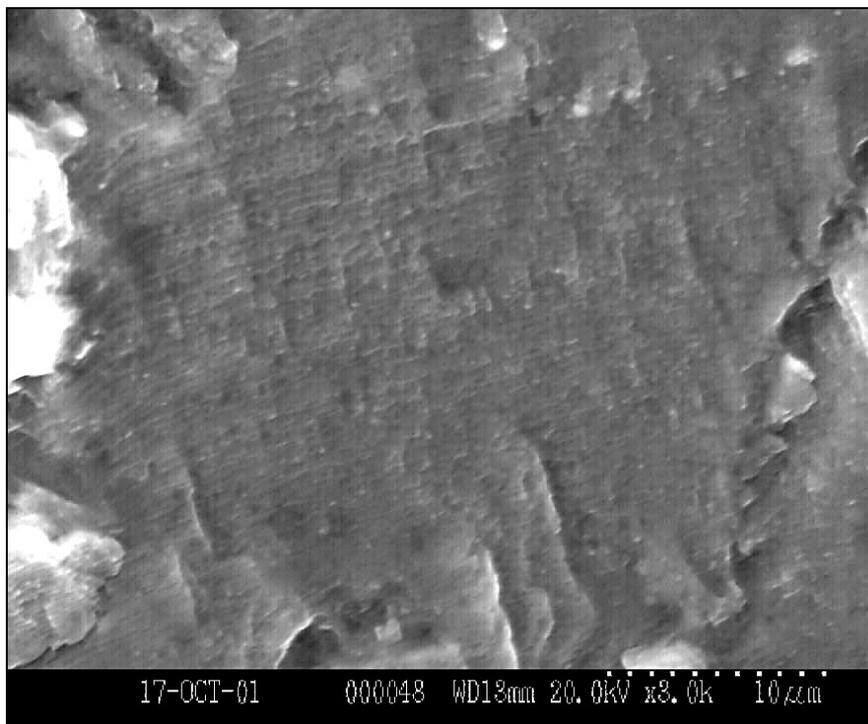
Figure 10 - Close view of the region of fracture surface indicated in figure 9. Fine fatigue striations indicated the directions of crack growth (secondary electron image).

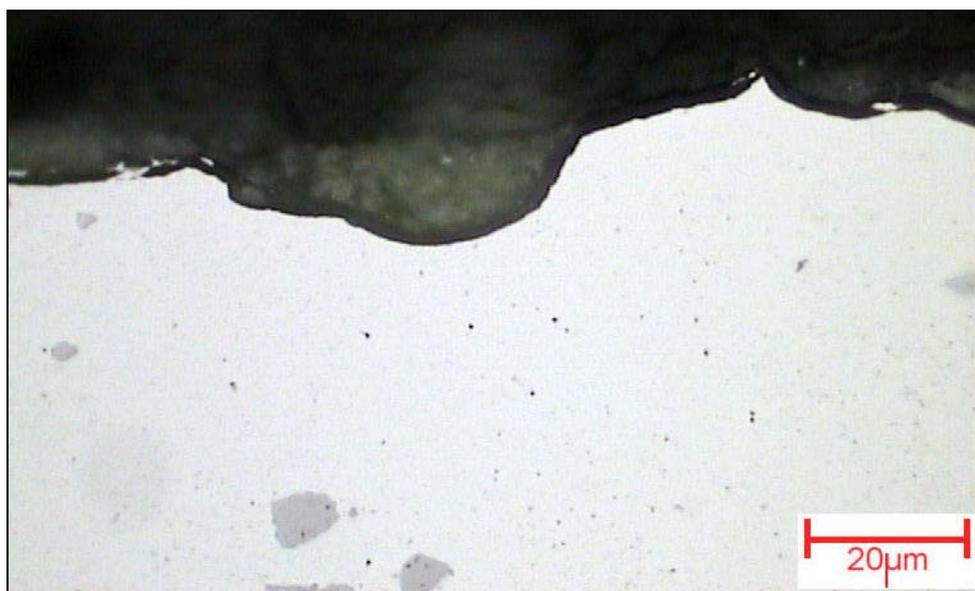
- (1) The surface pitting detailed at 3.A.(3) above was *estimated* to be up to 0.05mm (0.002in) in depth. The anodised coating was found to be intact and unbroken across the entire surface of the microsection, including within the pits. There was no evidence of in-service corrosion (figure 11).

Figure 11 - Microsection XX, taken through the location indicated in figure 3. The pitting was consistent with the application of excessive voltage, during anodising. There was no evidence of in service corrosion.
